Accessibility Report

New Zealand
Police Museum
June 2021

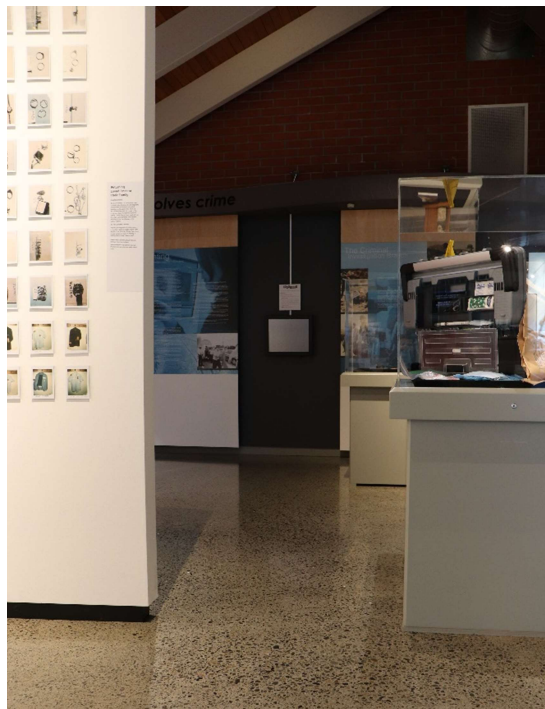
The first accessibility issue relates to the width of walkways. It is recommended that doorways are a minimum of 760mm, but 810mm is more ideal, while walkways should be a minimum of 1200mm. These measurements allow for a wheelchair user or a person with a companion to easily navigate the space. In the Police Museum, there are several examples where the minimum measurements have not been met. In particular, the spaces between cases and surrounding walls in the Operation Overdue and Forensic Files exhibition spaces are narrow. Between the right protruding wall of Operation Overdue and the forensic kit case of Forensic Files, there is a gap of 870mm. While a wheelchair would be able to fit through this space, a person with a companion would be

required to take a longer journey around the case to see the timeline of Operation Overdue.

Image 1: Gap between the right protruding wall of and the forensic kit case

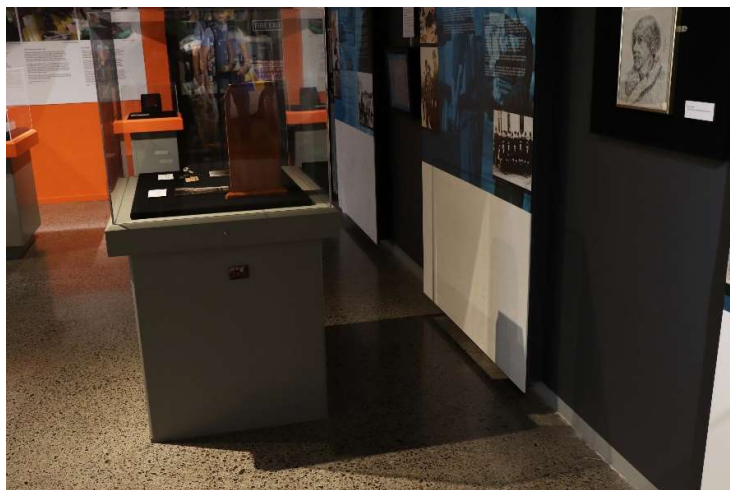
Not far from this narrow gap, is one that is even more so. Between the bottle case of Forensic Files and the wall behind it is a mere 650mm. There is no need for a person to go through the space, yet, there is a panel on the wall behind the case. It is nearly impossible for people in wheelchairs to be able to read this panel easily.

Image 2: Gap between the bottle case and the wall behind it

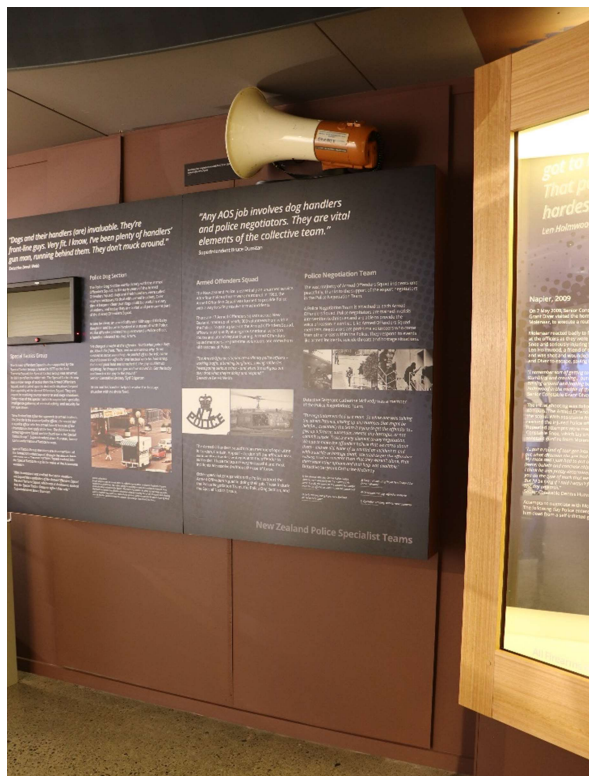
Similarly, the height of most exhibition labels or wall panels is also outside the recommended limits. Ideally, all labels or wall panels should be placed on the wall at a height between 1200mm to 1675mm. This height means that wheelchair users do not have to crane their necks to look up or down to read the text. It is also difficult for children and little people to read anything over 1675mm. In the two galleries, the height of labels and panels range from ground level (0mm) to over 2220mm.

Image 3: Megaphone placed at around 2220mm on the wall.

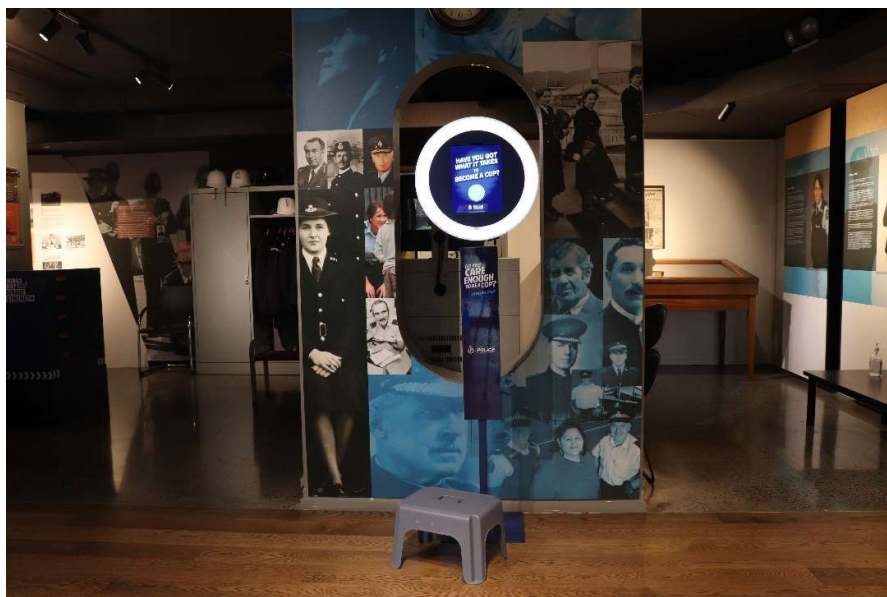
Interactive elements of exhibits should be between 900mm and 1200mm unless they are placed horizontally where they should be between around 900mm. These measurements make the interactive at an ideal height for wheelchair users, little people, and children, as well as non-disabled people. The interactive screens, police recruitment activity, and elements of both the fingerprint scanner and dress up uniforms are too tall for wheelchair users, little people, and children to use without assistance.

Image 4: Police recruitment activity, measuring between 1300mm and 1555mm.

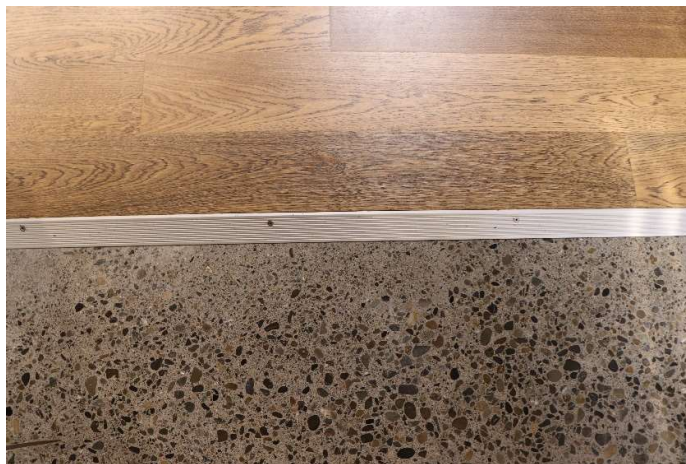
In the Front Gallery, there are two types of flooring: wood panelling and polished concrete. There is a strip of metal covering the lip between the two types of flooring; however, the metal's silver colour blends into the concrete, making it difficult to see. This strip is a trip hazard, especially when going from the concrete to the wood, as it is slightly raised. Placing reflective tape along the strip will be a simple, but effective remedy.

Image 6: Metal strip between wooden and concrete flooring.

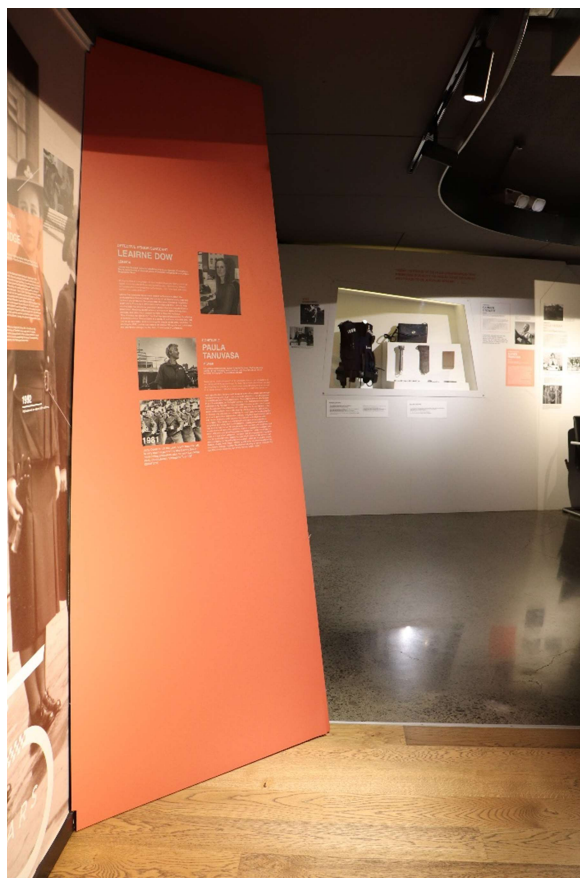
The outer wall of the Women in New Zealand Police exhibition space has been extended and built on an angle, with the base sitting further out than the top. While this allows the space to have an extra two wall classes, the colour of the wall means that the slope is invisible to anyone who is blind or has low vision. Visitors can walk into this wall easily and, therefore, it is another trip hazard. Future wall cases should be built straight up and down.

Image 7: Angle of the outer wall of the Women in New Zealand Police exhibition space.

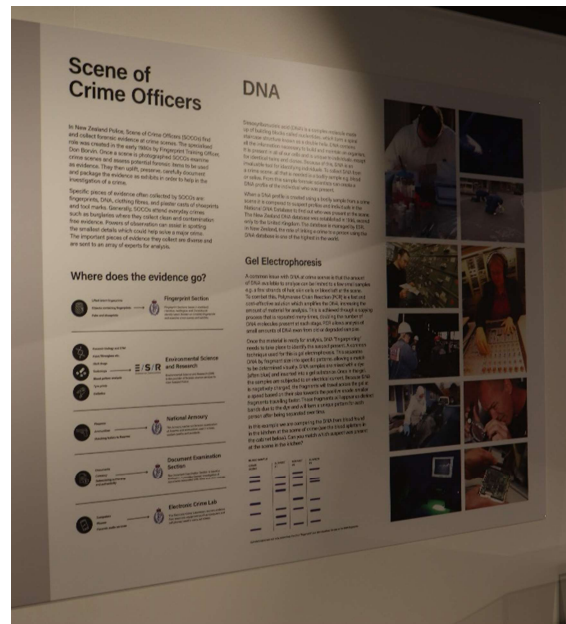
Finally, the amount of text on a label or panel is important. Generally, it is recommended that labels should be a maximum of 50 words, while wall panels can be longer at around 200 words. This recommendation is not just for people with disabilities, but people who have limited attention spans. People who do not have the ability or patience to read a long sign will move on without reading it. In the Police Museum, most labels fulfil their requirements, but the wall panels do not because of the nature of the stories the museum tells. It may be difficult for the wall panels to be shorted to fit recommended limits, but this should be taken into consideration.

Image 11: White section of the Forensic Files wall panel with approximately 550-700 words, excluding the text in the diagrams.

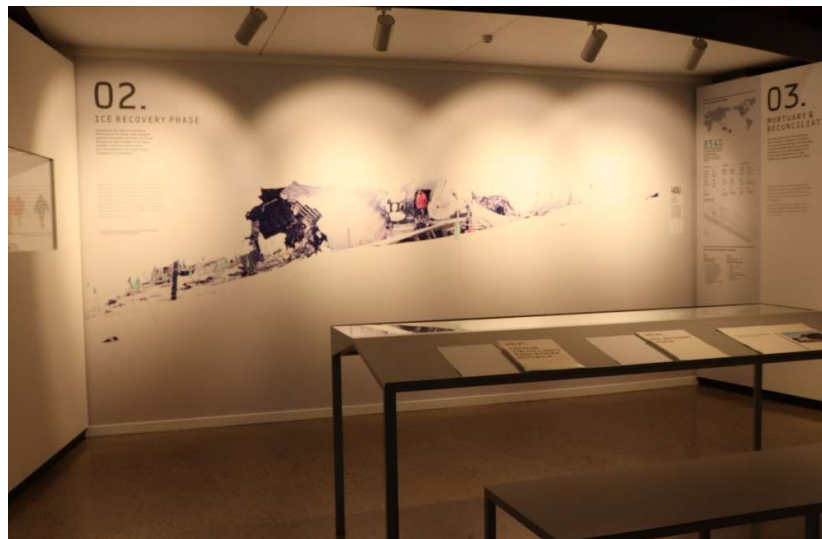
The Operation Overdue exhibition space has been designed to mimic the snow conditions faced by the Erebus disaster victims, again with white walls and bright lights.

Image 13: The Operation Overdue exhibition space.

Social stories would be an ideal method to assist with all of the sensory issues, as they let people know what lighting conditions or sounds to expect and let them prepare for it.

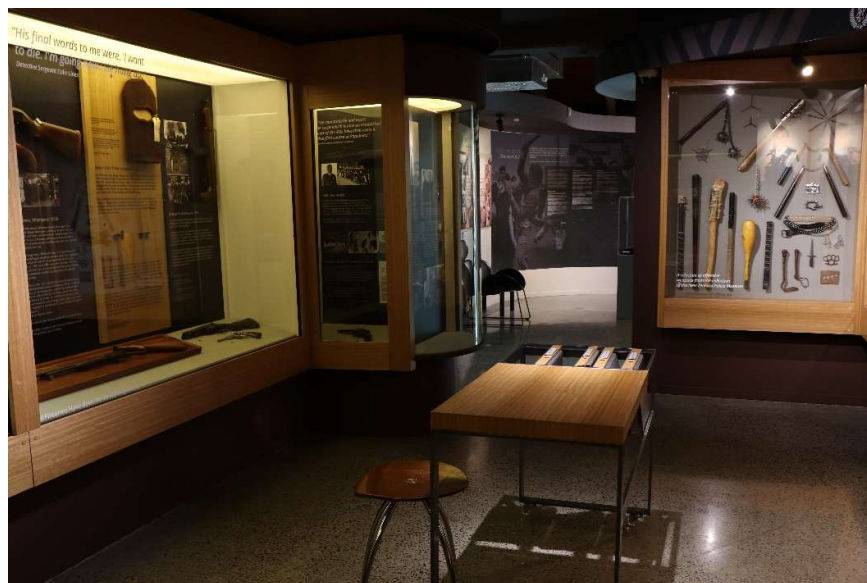
various videos of cadet training, including videos of people using guns and tasers. Some people may believe that they are at risk of being injured by the people using these weapons. Similarly, in the Back Gallery, there is one case that contains a taxidermied dog, Rhys, and several cases displaying weapons. Some people may believe that the dog is alive and will chase or hurt them, or that the weapons will hurt them when they are in their vicinity.

Image 15: Weapons on display in the Armed Forces exhibition space.

I recommend the use of social stories to help with this issue. Social stories are an ideal method as they will explain what is happening in each location, letting people know what to expect and let them prepare for it.

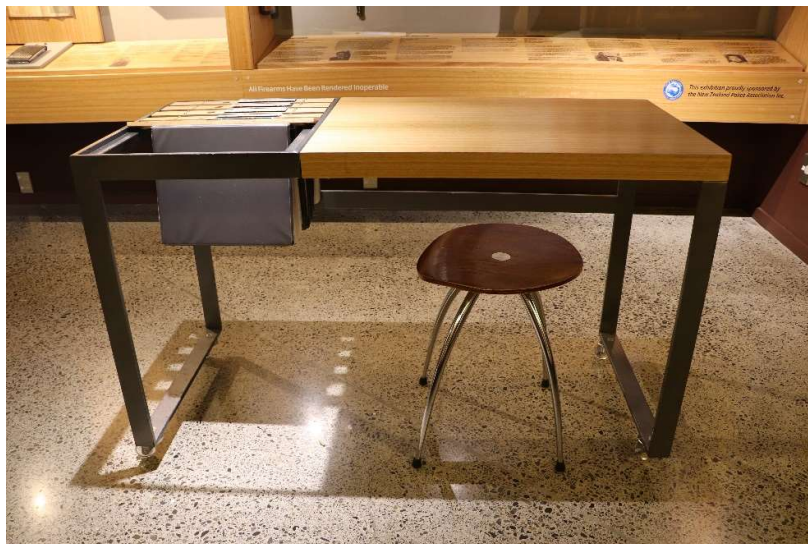
Yet, even though the stool measures at 480mm, it is the least accessible chair as it does not have armrests and sits under a table that is on wheels. If a person tried to use the table to help them stand up, the table would move in the opposite direction and could cause a fall.

Image 16: The stool found beneath the table on wheels.
