Te Whare o Rehua Sarjeant Gallery: Lessons in future- proofing

In May 2014, the Sarjeant Gallery relocated to a temporary site to allow for the earthquake strengthening and redevelopment of its heritage building. A year later its temporary gallery flooded, leaving a caked-on layer of toxic dust. This case study outlines some lessons learned.

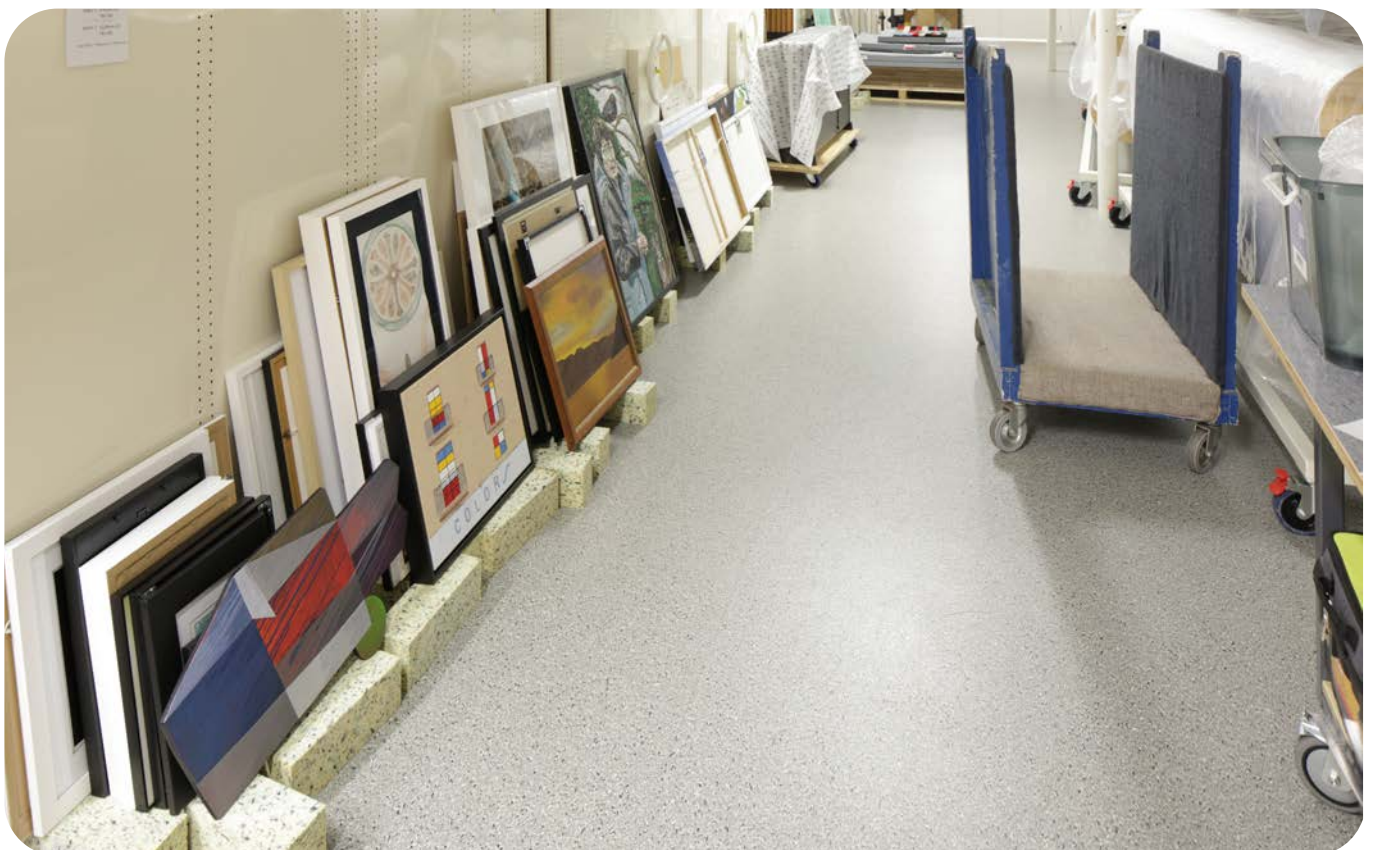
BELOW: Artworks were removed from the ground floor gallery and placed on foam chocks in the upstairs collection store as a precaution when another flood event was predicted in 2017 which didn't eventuate. Photo courtesy of Te Whare o Rehua Sarjeant Gallery.
